Technical Report CERC-93-14
August 1993

Revetment Stability Tests for Sargent Beach, Texas

Prepared for U.S. Army Engineer District, Galveston
Galveston, TX 77550

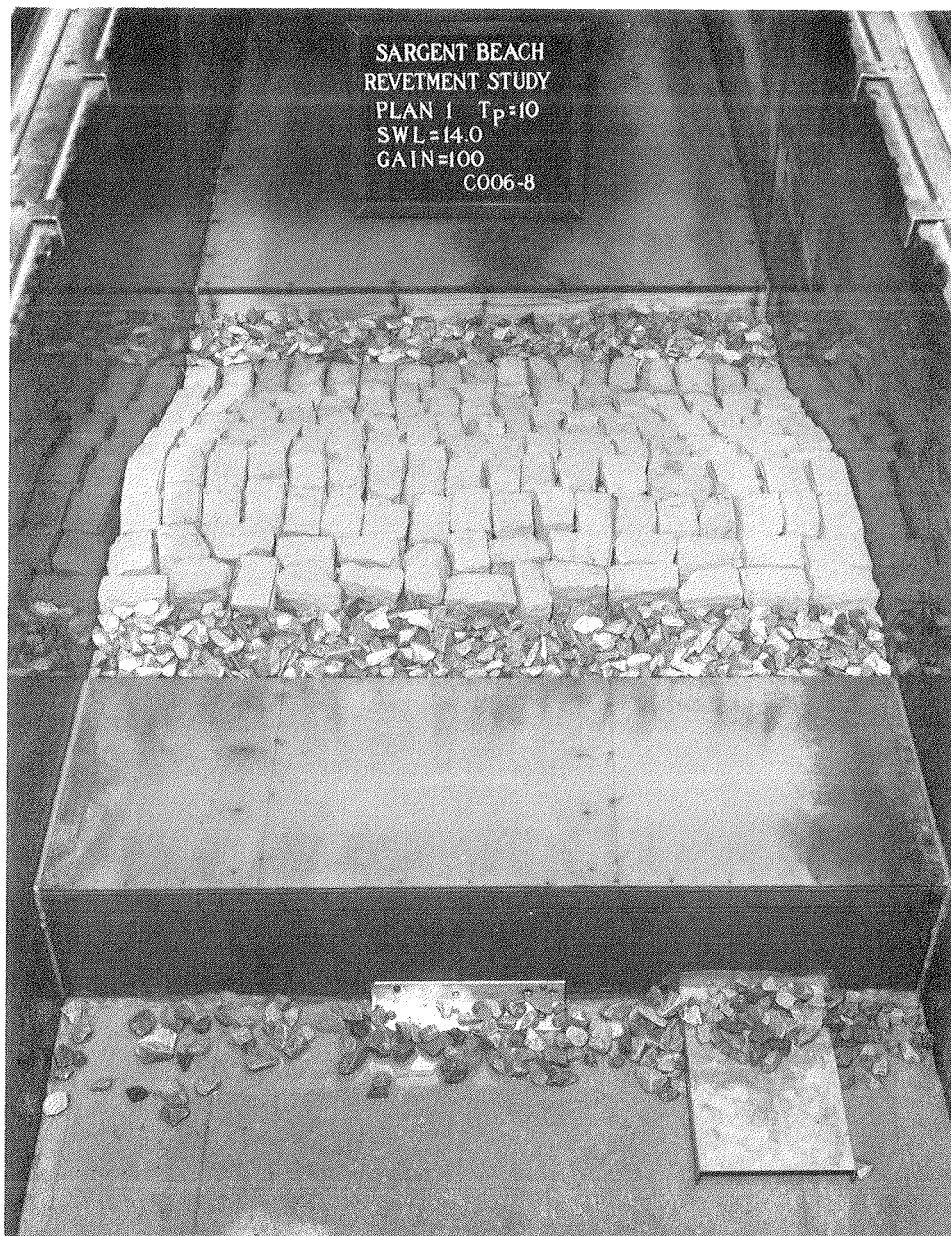
Photo 3. Side view of Plan 1 after wave attack

Photo 4. Sea-side view of Plan 1 after wave attack

Photo 5. Land-side view of Plan 1 after wave attack

Plan 1 was subjected to the 24-step test delineated in Table 1. Some landward displacement from the shore-side crest of the structure of the 200- to 1,000-lb stone was observed at the +4-ft swl. Minor reorientation of some 200- to 1,000-lb toe stone also was observed. No armor stone movement was detected. The +7-, +9.5-, and +14-ft swl's supported progressively larger waves; however, much of this energy passed over the structure and only two additional 200- to 1,000-lb stones shore-side of the crest were displaced. Photos 3-5 show the after-testing condition of the structure.

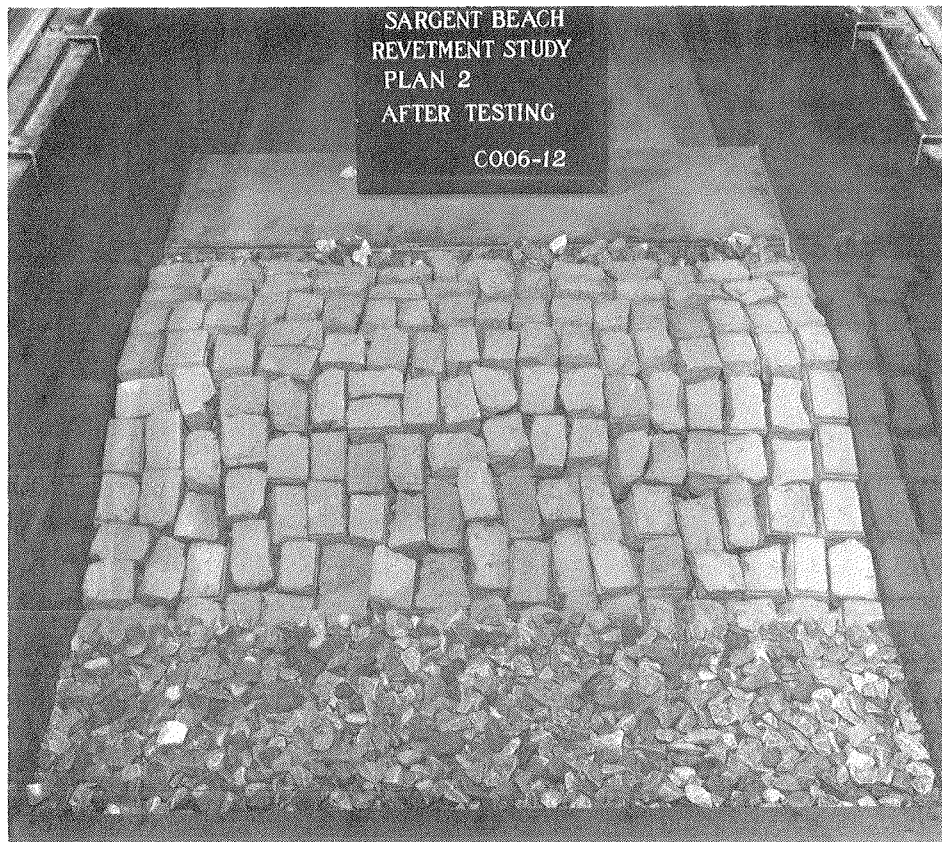
Photo 6. Side view of Plan 2 after wave attack

Photo 7. Sea-side view of Plan 2 after wave attack

Photo 8. Land-side view of Plan 2 after wave attack

Plan 2 was tested for the six-step storm given in Table 2. Only the +4-ft swl was tested, since this water level appeared to be the most critical to toe stability in previous tests of Plan 1. Plan 2 proved to be stable. Similar to Plan 1, minor reorientation of some 200- to 1,000-lb toe stone was observed. Also, several additional 200- to 1,000-lb stones were displaced from the shore-side crest of the structure. The after-testing condition of the structure is shown in Photos 6-8.

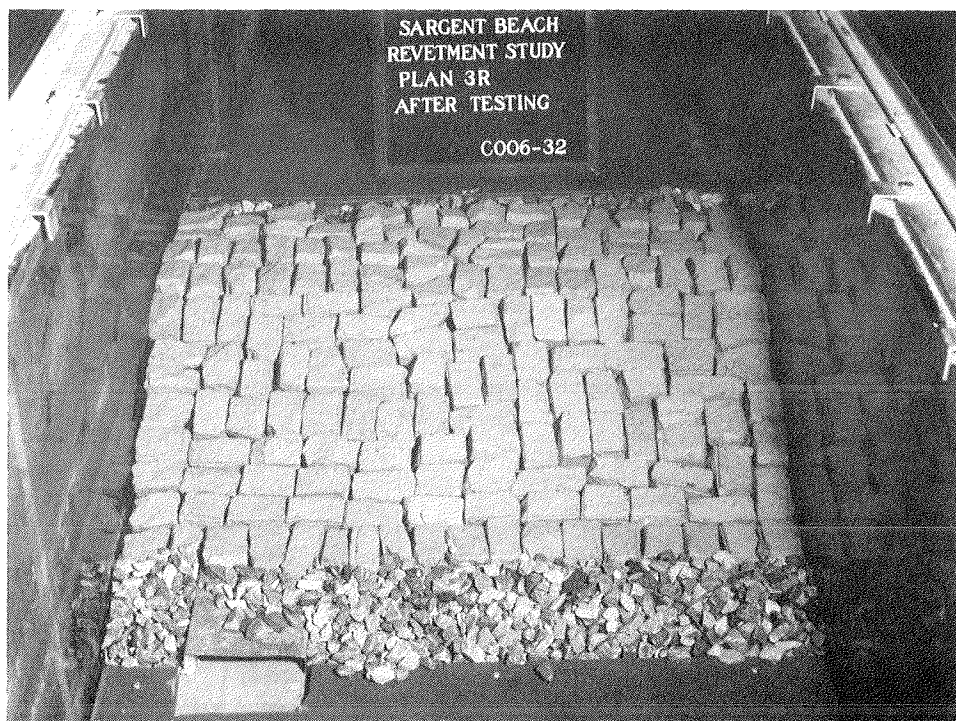
Photo 11. Side view of Plan 3R after wave attack

Photo 12. Sea-side view of Plan 3R after wave attack

Plan 3R was tested for the abbreviated worst case eight-step storm given in Table 4. Similar to previous plans, some reorientation of the 200- to 1,000-lb toe stone was observed and several 200- to 1,000-lb stones were displaced from the shore-side crest of the structure. The 5-ton armor was generally stable; however, one stone was displaced from the crest of the revetment during step 8 (Table 4 at the -8.6-ft mlt toe condition). The after-testing condition of the structure is shown in Photos 11 and 12.

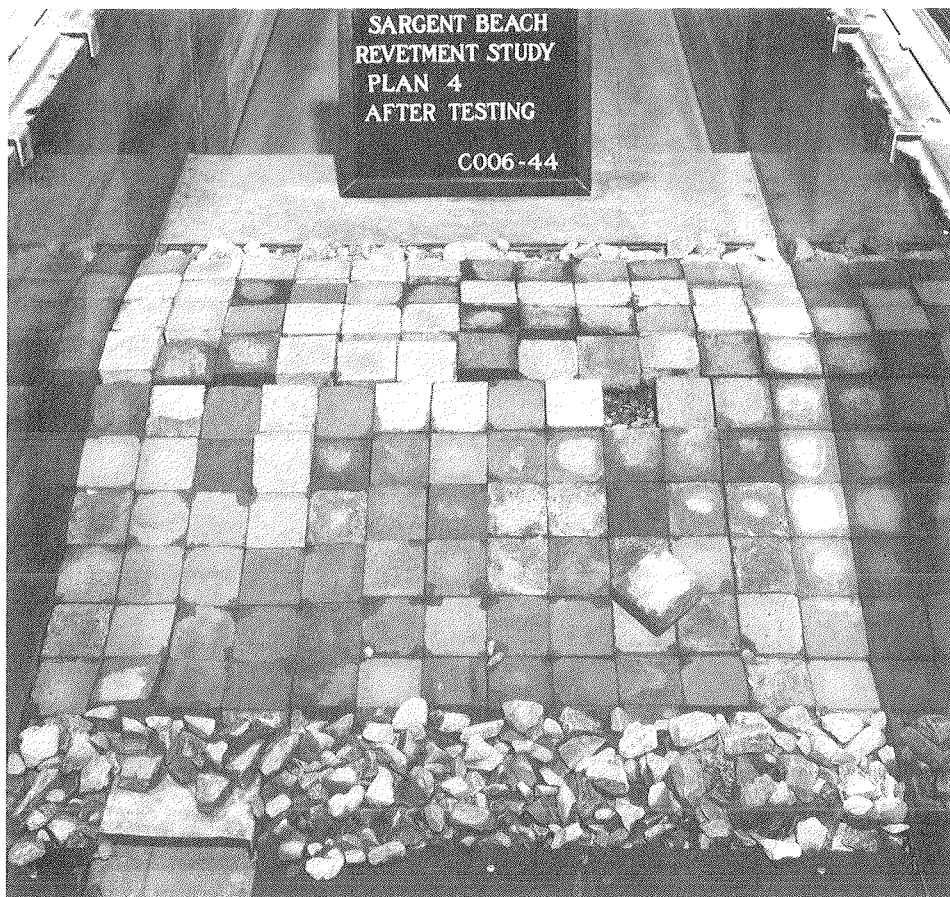
Photo 13. Side view of Plan 4 after wave attack

Photo 14. Sea-side view of Plan 4 after wave attack

Seaward slippage of the 6.2-ton toe blocks was initiated at the +4.0-ft swl. Also, as the toe blocks moved slightly seaward, the next five rows of blocks above them packed downslope. This left a gap of about 6-9 in. (prototype) between the upper row of slope blocks and the first row of crest blocks. Several of the seaside blocks were observed to lift slightly during wave attack; however, none were displaced. A small amount of additional slippage of the seaward blocks was observed during the +7.0- and +9.5-ft swl's (the above-described gap was about 10 in. wide by conclusion of the +9.5-ft swl). Continued lifting and reseating of the blocks was observed at the +14-ft swl, with one block being displaced downslope during step 24 (Table 3 at the -8.6-ft mlt toe condition). Photos 13 and 14 show the section after wave attack. The gap between the upper row of slope blocks and the first row of crest blocks was about 1 ft (prototype) at the conclusion of the test. The stability response of the concrete blocks in Plan 4 is considered marginally acceptable.

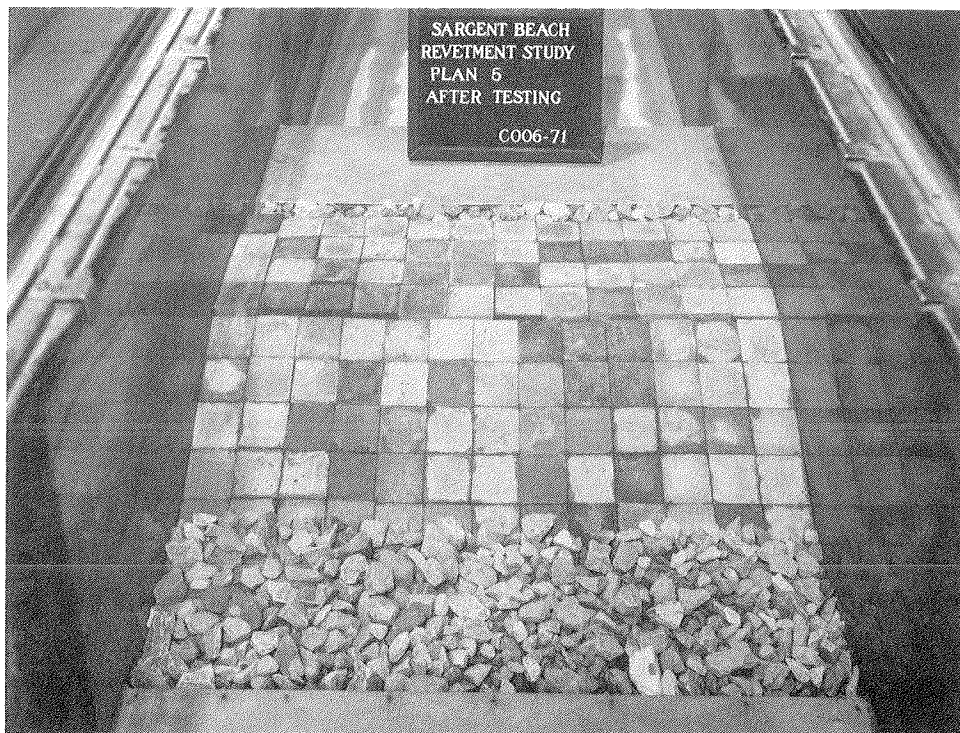
Photo 17. Side view of Plan 5 after wave attack

Photo 18. Sea-side view of Plan 5 after wave attack

Plan 5 (Figure 8) was similar to Plan 4 except it was assumed that the erosion depth in front of the structure was 5 ft less (sea bottom was raised from -8.6 ft mlt to -3.6 ft mlt). Also, the upper toe elevation was raised from -5.0 ft mlt to -3.6 ft mlt. Plan 5 was subjected to the same 24-step test as Plan 1 (Table 1). Testing at the +4-ft swl produced no movement of the concrete blocks. A few of the smaller 200- to 2,000-lb shore-side crest stones were displaced. Two additional crest stones were displaced during continued testing at the +7-, +9.5-, and +14-ft swls. No movement of the concrete blocks could be detected at any of the swl's. Photos 17 and 18 show the structure after wave attack.

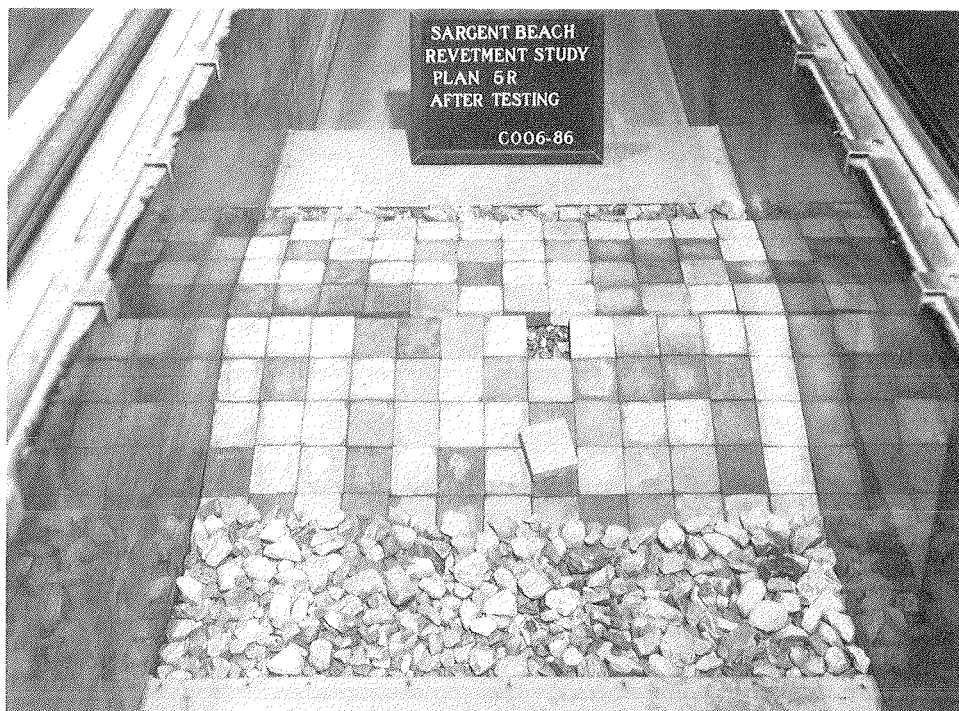
Photo 19. Side view of Plan 5R after wave attack

Photo 20. Sea-side view of Plan 5R after wave attack

Photo 21. Land-side view of Plan 5R after wave attack

Plan 5R (Figure 8) was a rebuild of Plan 5. It was tested to verify the stability response of the concrete blocks for the -3.6-ft erosion depth. Plan 5R was subjected to the 16-step test listed in Table 6. Results verified the outcome of the initial test, i. e., no movement of the concrete blocks was detected at any of the swl's until the final step of the test was reached. The 10-sec, 13.2-ft waves at the +14-ft swl (step 16, Table 6) displaced one block from the seaward face (Photos 19-21). Also, a few of the smaller 200- to 2,000-lb shore-side crest stones were displaced at the +4- and +7-ft swl's.

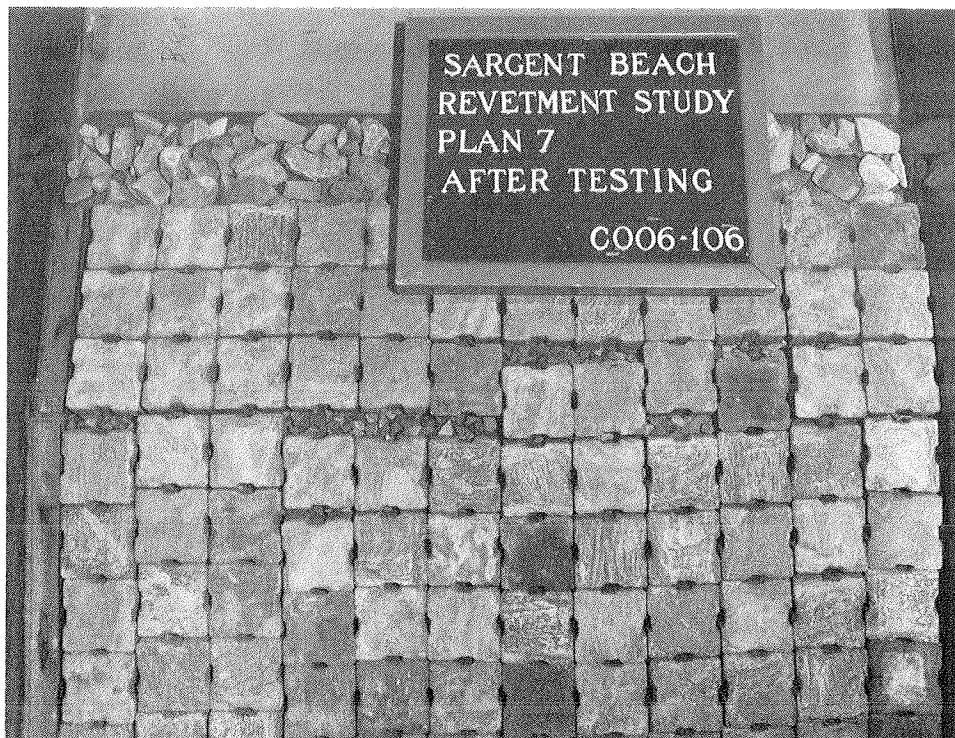
Photo 31. Side view of Plan 7 after wave attack

Photo 32. Sea-side view of Plan 7 after wave attack

Photo 33. Land-side view of Plan 7 after wave attack

Photo 34. Overhead view of Plan 7 after wave attack

Plan 7 was subjected to the 20-step test given in Table 7. Slight seaward shifting of the first row of concrete blocks was initiated at the +4-ft swl. As the toe blocks shifted seaward, the six rows of onslope blocks packed downslope, leaving a gap between them and the three rows of crest blocks. This slow progressive movement continued through the +7-ft swl. At the conclusion of testing, the gap between the slope and crest blocks varied from a few inches to about 1.5 ft (prototype). Individual concrete blocks appeared to be hydraulically stable, i.e., no lifting or displacement was observed. Photos 31-33 show the overall condition of the section after wave attack and Photo 34 shows details of the block separation.

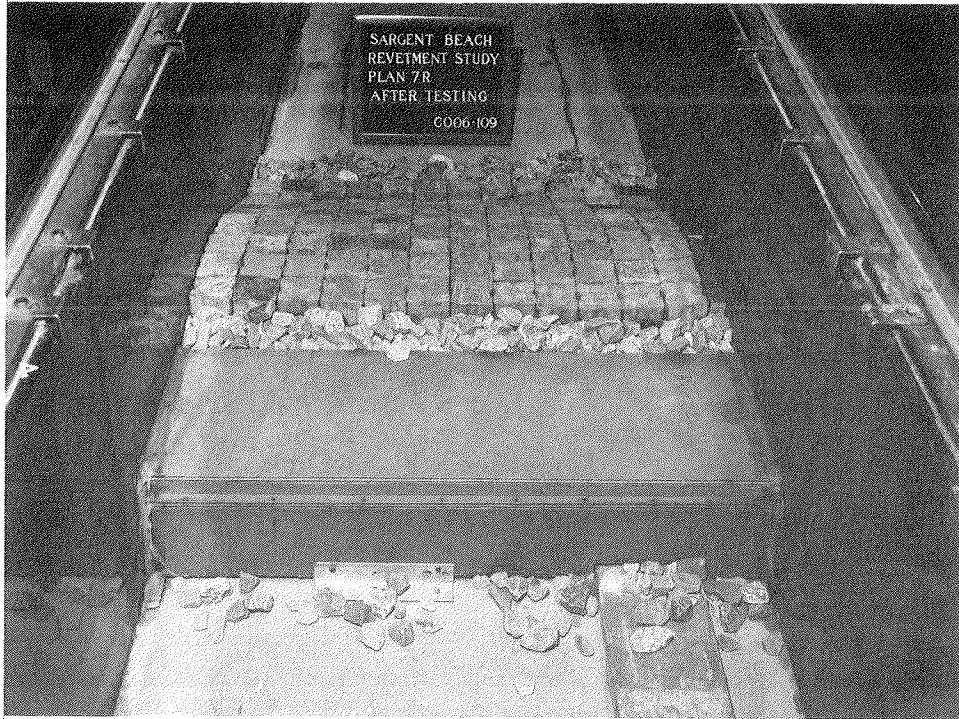
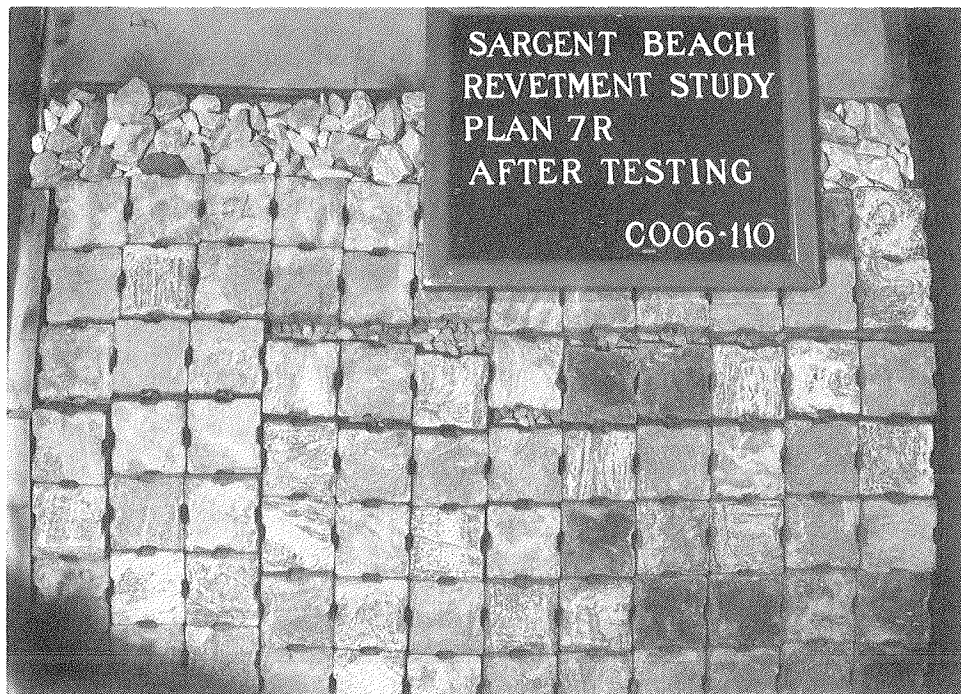
Photo 35. Side view of Plan 7R after wave attack

Photo 36. Sea-side view of Plan 7R after wave attack

Photo 37. Land-side view of Plan 7R after wave attack

Photo 38. Overhead view of Plan 7R after wave attack

Plan 7R (Figure 11) was a rebuild of Plan 7. Subjection to the 10-step hydrograph given in Table 7 verified results of the first test, i.e., a gap, varying in width from a few inches to 1.5 ft, developed between the slope and crest blocks as a result of toe slippage and subsequent downslope slippage of the slope blocks. Again, no lifting or displacement of individual blocks was observed. Photos 35-38 show the final condition of the test section. As can be observed in after-testing photos, the 200- to 2,000-lb toe and crest stone experienced some displacement.

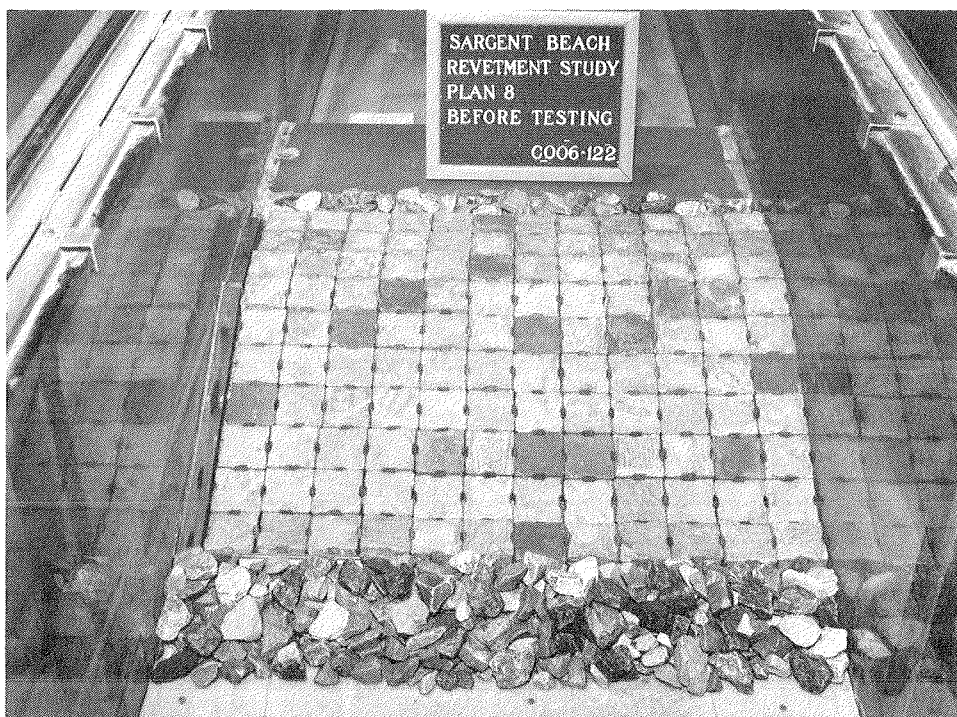
Photo 39. Side view of Plan 8 before wave attack

Photo 40. Sea-side view of Plan 8 before wave attack

Plan 8 (Figure 13 and Photos 39 and 40) was the same as Plan 7, except that the toe stone weight was increased to 200 to 4,000 lb in an effort to improve its stability and hopefully reduce sliding of the concrete blocks. Subjection to the same wave conditions as Plan 7 produced improved results; i.e., the toe stone was stable and the maximum gap between the slope and crest blocks was reduced to about 1 ft (prototype). Photos 41-44 show the structure after wave attack.

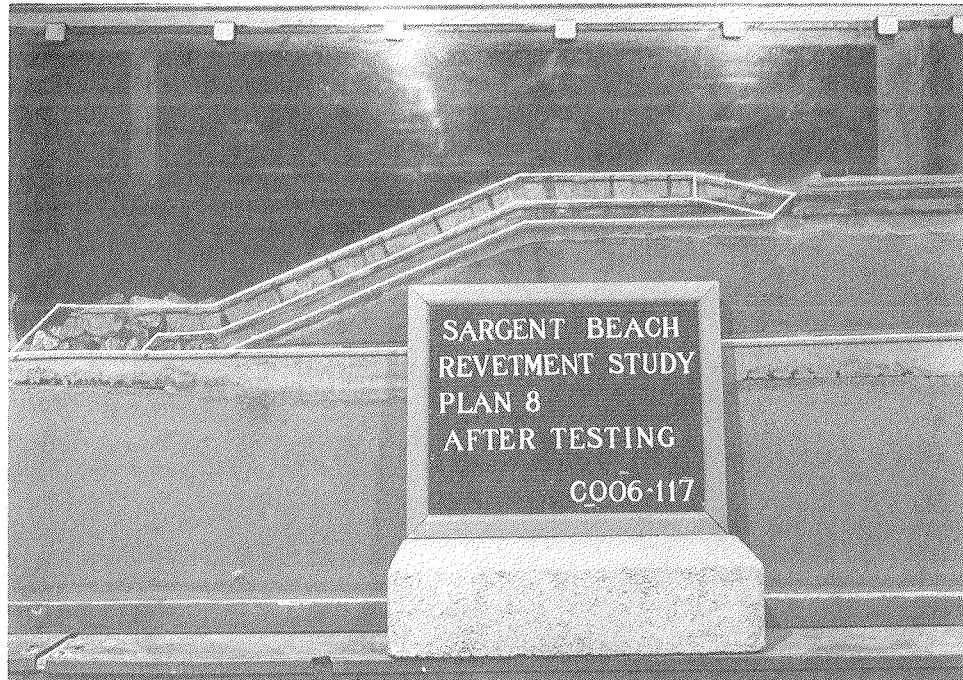
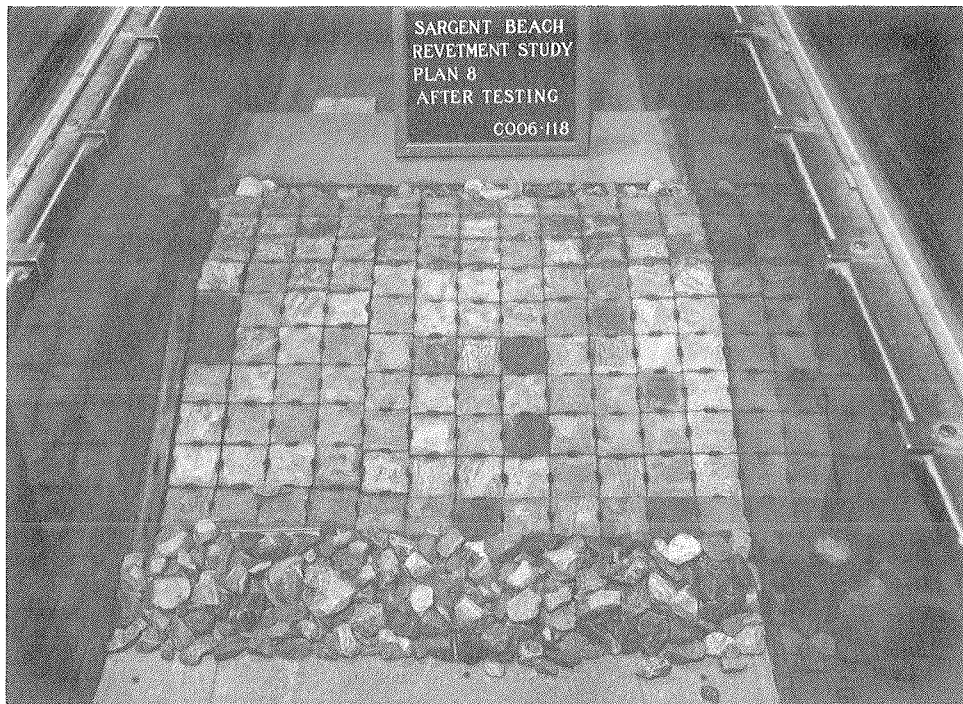
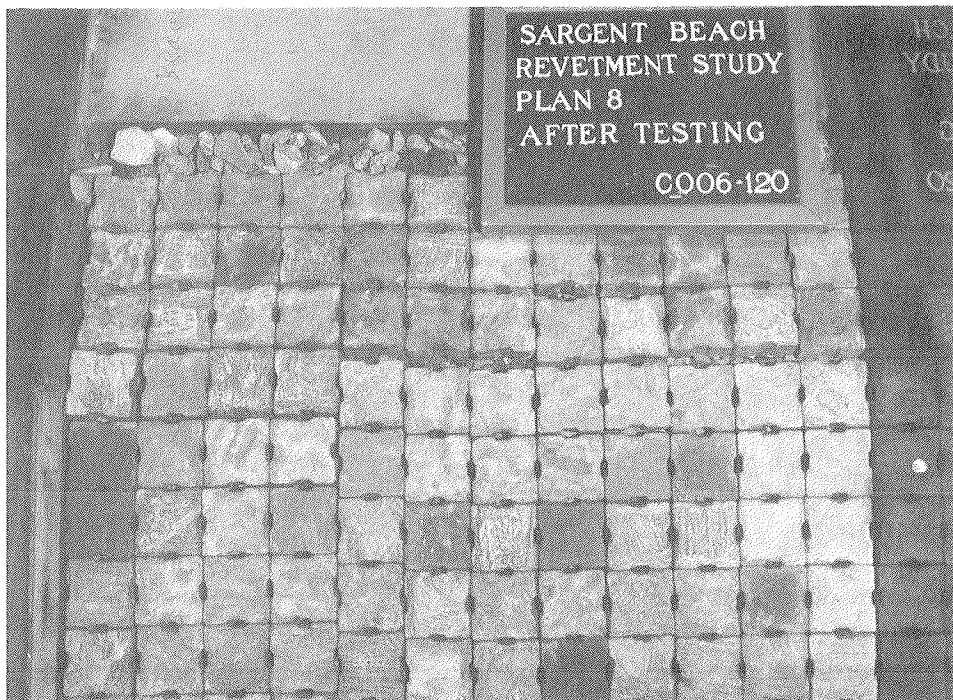
Photo 41. Side view of Plan 8 after wave attack

Photo 42. Sea-side view of Plan 8 after wave attack

Photo 43. Land-side view of Plan 8 after wave attack

Photo 44. Overhead view of Plan 8 after wave attack

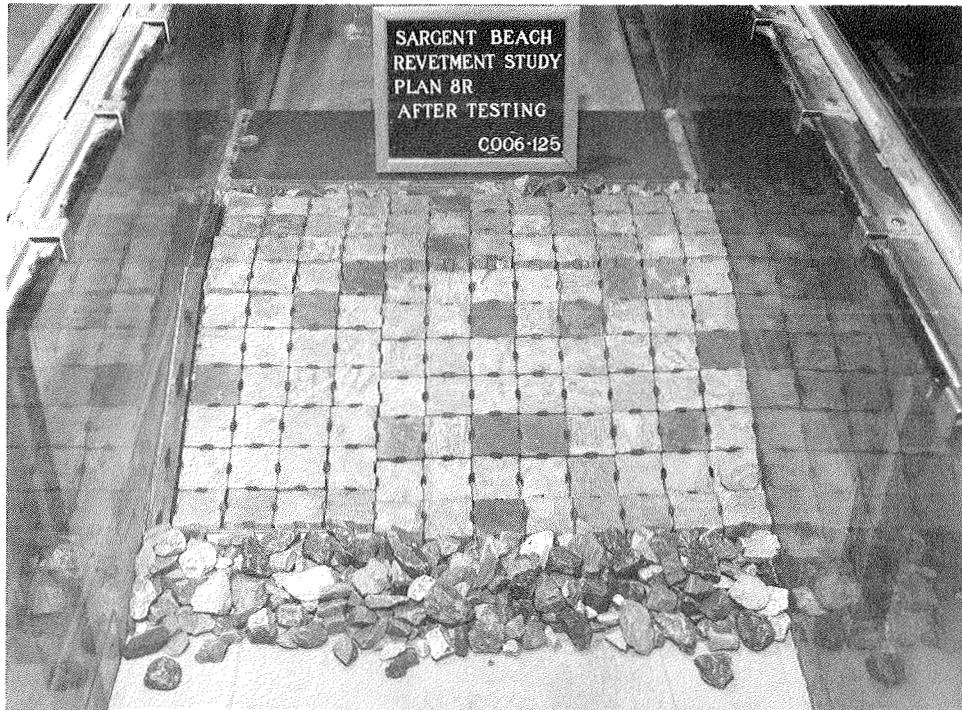
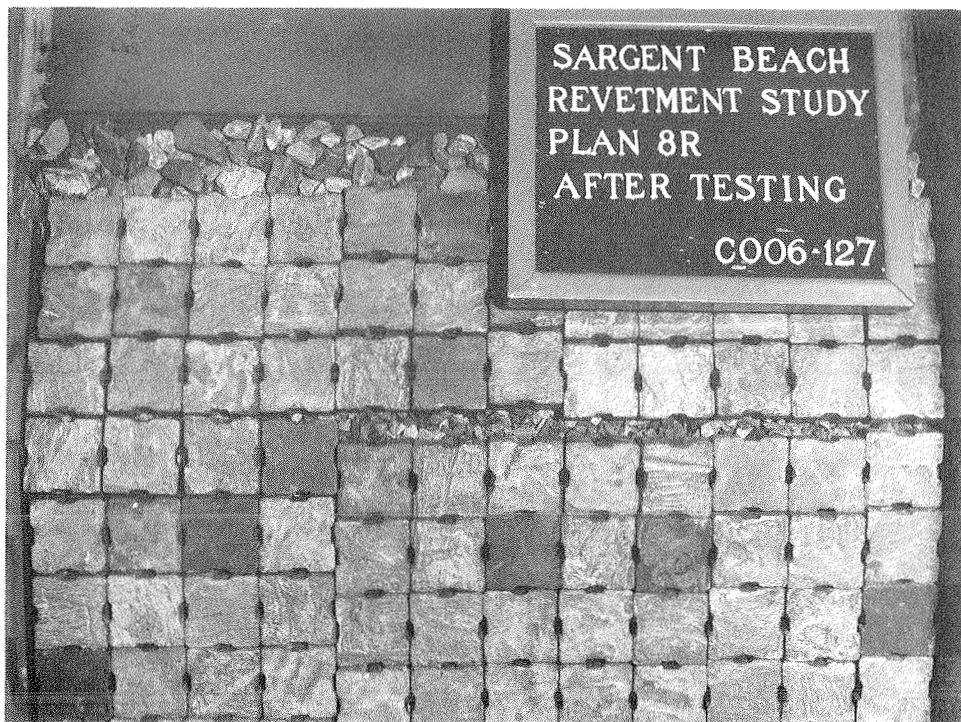
Photo 45. Sea-side view of Plan 8R after wave attack

Photo 46. Overhead view of Plan 8R after wave attack

Plan 8R (Figure 13) was a rebuild of Plan 8. Subjection to the hydrograph given in Table 8 verified results of the first test, i.e., a gap developed between the slope and crest blocks as a result of toe slippage and subsequent downslope slippage of the slope blocks. Again, no lifting or displacement of individual blocks was observed. Photos 45 and 46 show the final condition of the test section.

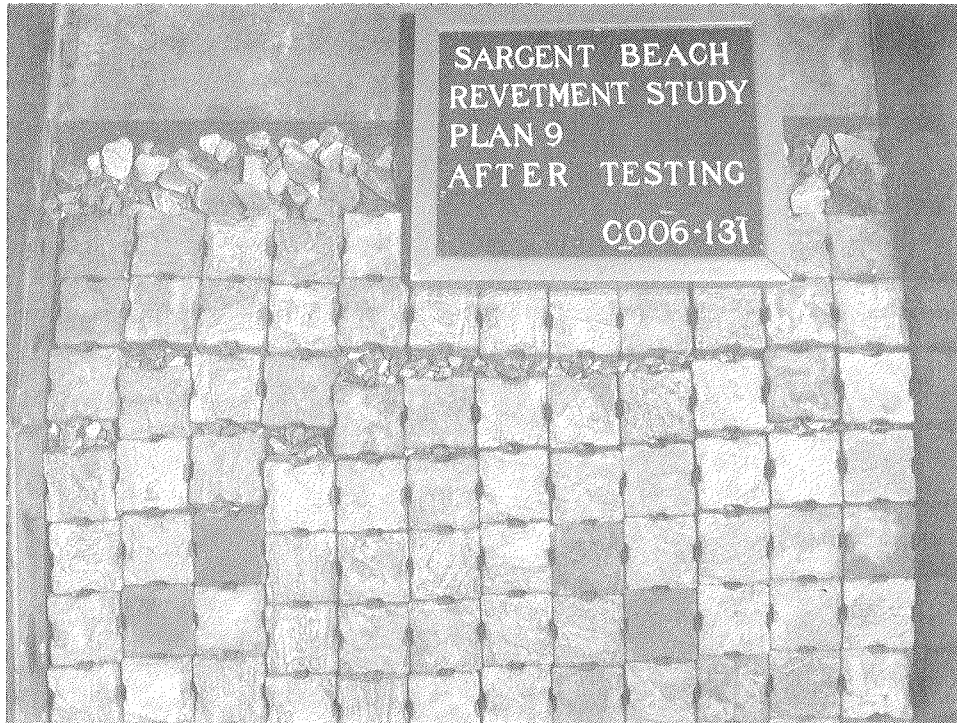
Photo 47. Side view of Plan 9 after wave attack

Photo 48. Sea-side view of Plan 9 after wave attack

Photo 49. Overhead view of Plan 9 after wave attack

Plan 9 (Figure 14) was similar to Plan 8, except that an additional row of concrete blocks was added to the toe and a proportionate amount of 200- to 4,000-lb toe stone was removed. Testing with the same wave conditions as Plan 8 produced similar results, i.e., a gap varying from a few inches to 1 ft developed between the slope and crest blocks as a result of toe slippage. As shown in Photos 47-49, the final condition of the structure was similar to that observed for Plans 8 and 8R.

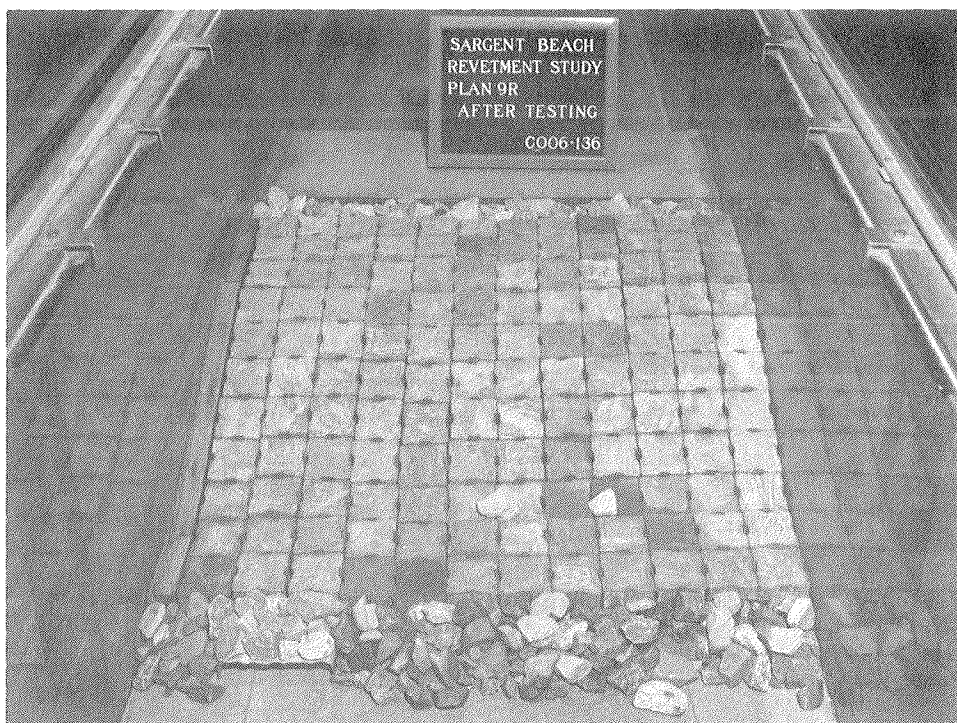
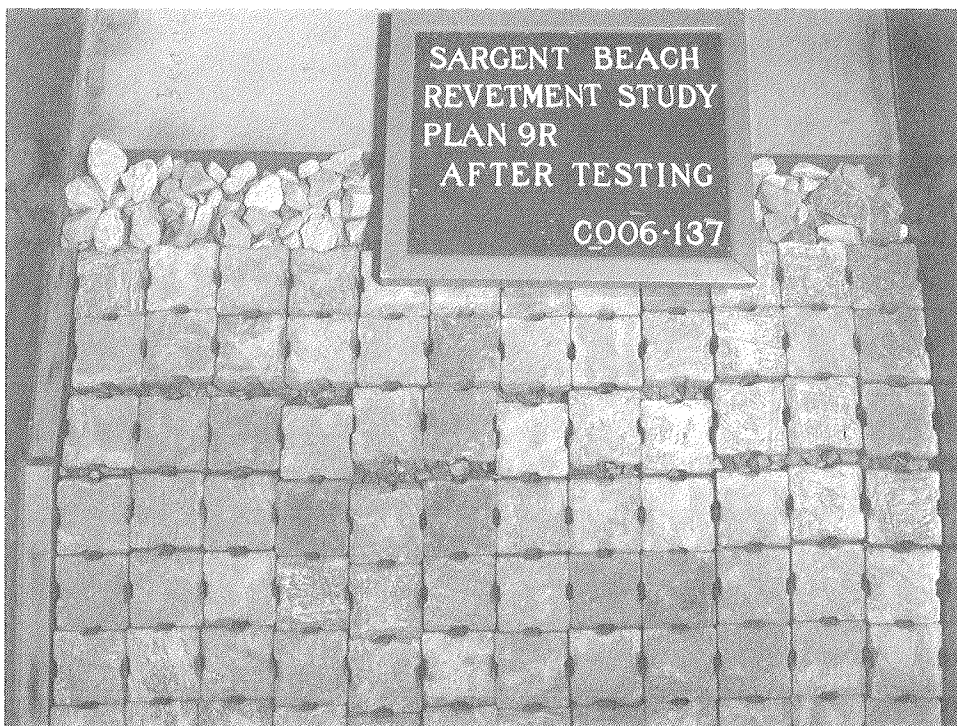
Photo 50. Side view of Plan 9R after wave attack

Photo 51. Sea-side view of Plan 9R after wave attack

Photo 52. Overhead view of Plan 9R after wave attack

Plan 9R (Figure 14) was a rebuild of Plan 9. It was tested with the 10-step hydrograph given in Table 2. Again, a gap developed between the slope and crest blocks as a result of toe slippage and subsequent downslope slippage of the slope blocks. Final condition of the structure (Photos 50-52) was similar to that observed for Plans 8, 8R, and 9, i.e., a gap that varied from a few inches to about 1 ft developed between the slope and crest blocks.
